GEO-ENVIRONMENTAL & GEOTECHNICAL ASSESSMENT (GROUND INVESTIGATION) REPORT

EGLEY ROAD, WOKING, GU22 0AF

Report Title: Geo-environmental & Geotechnical Assessment Ground Investigation Report for Egley Road, Woking, GU22 0AF

Prepared by: **JOMAS ASSOCIATES LTD** For: **WOKING FOOTBALL CLUB**

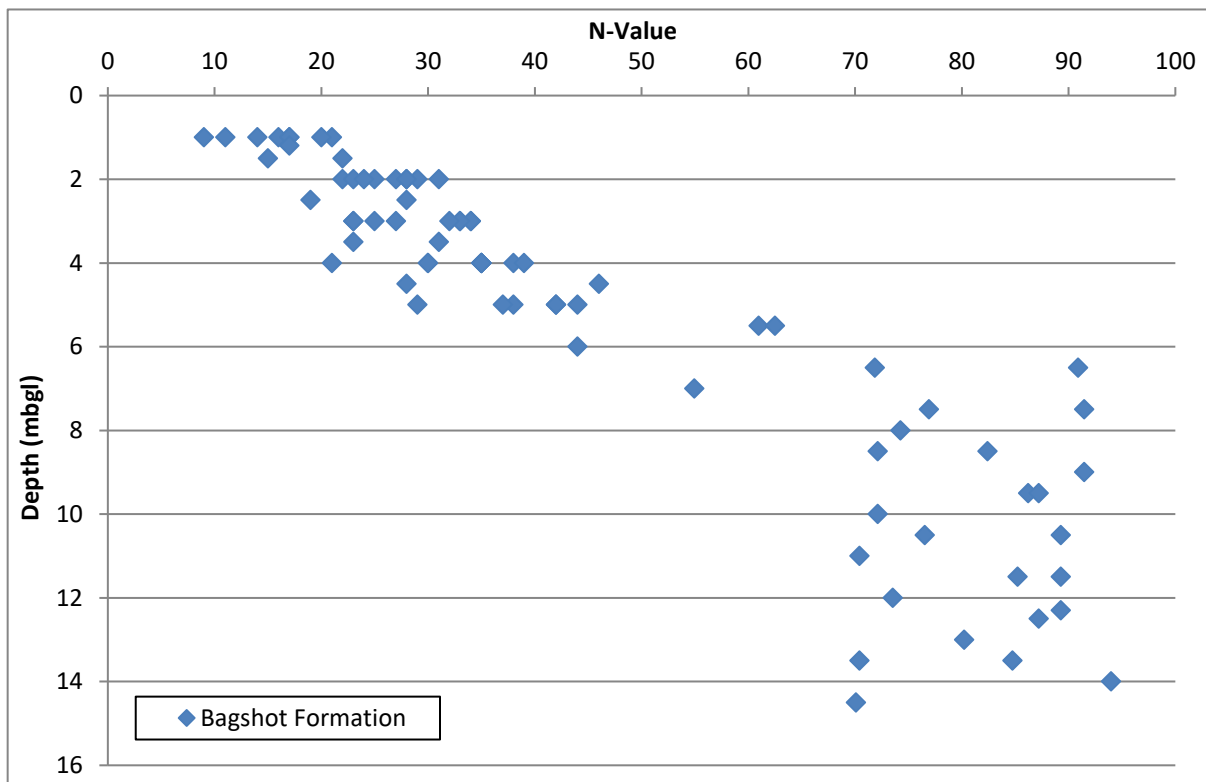
Figure 1: SPT 'N' Value v Depth

9.4.3 The results for the Bagshot Formation show a generally consistent increase with depth.

9.4.2 N_{equi} results have been calculated for both strata where the SPT crossed strata boundaries or where the full 300mm of penetration could not be achieved for 50 or fewer blows.

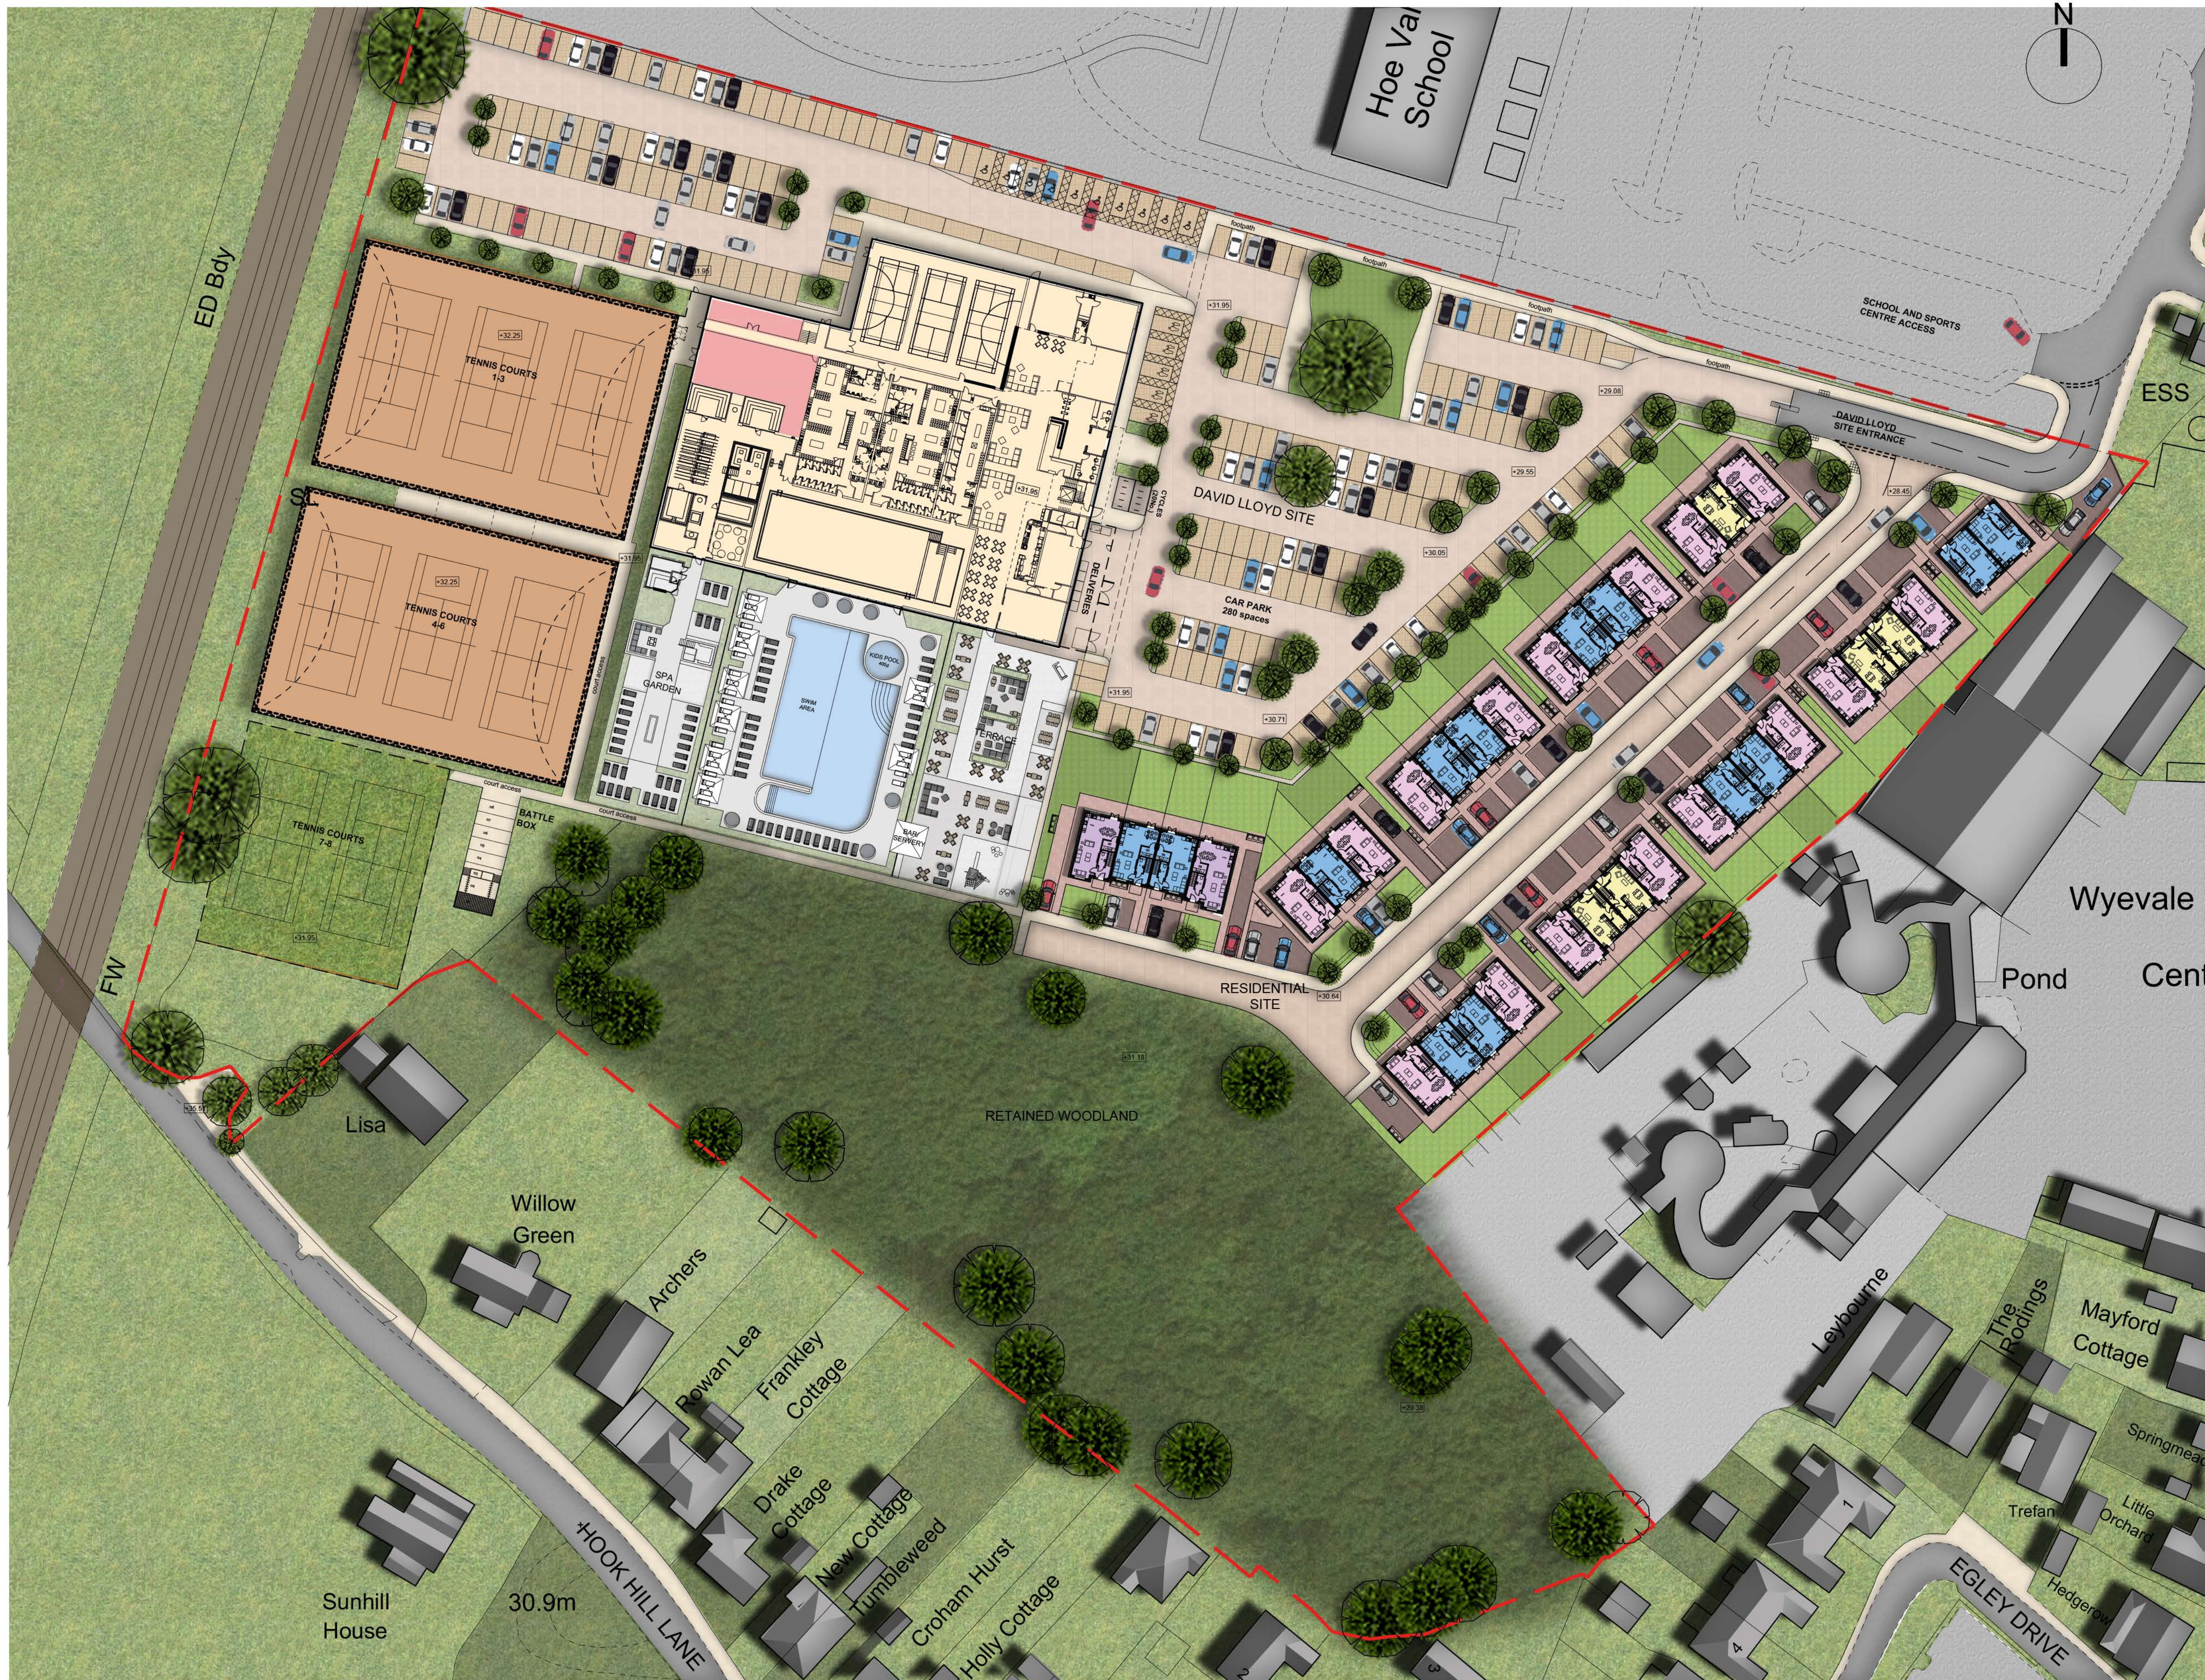
- Borehole Installs:
 WS2
 WS4
 WS5
 WS7
 WS10
- CBR Testing:
 TP1
 WS2
 WS5
 WS7
 WS10

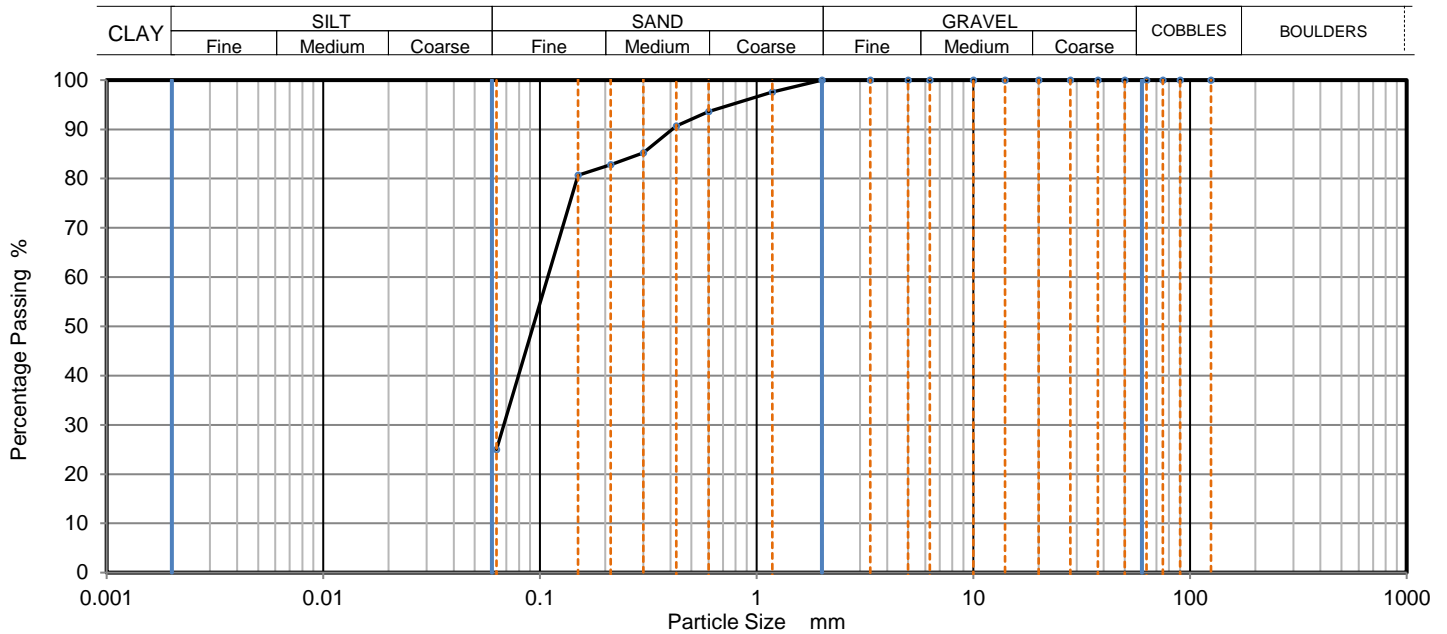
Laboratory Reference: 1173817
Hole No.: WS2
Sample Reference: Not Given
Sample Description: Greyish brown clayey SAND

Depth Top [m]: 4.50
Depth Base [m]: Not Given
Sample Type: D

Sieving		Sedimentation	
Particle Size mm	% Passing	Particle Size mm	% Passing
125	100		
90	100		
75	100		
63	100		
50	100		
37.5	100		
28	100		
20	100		
14	100		
10	100		
6.3	100		
5	100		
3.35	100		
2	100		
1.18	98		
0.6	94		
0.425	91		
0.3	85		
0.212	83		
0.15	81		
0.063	26

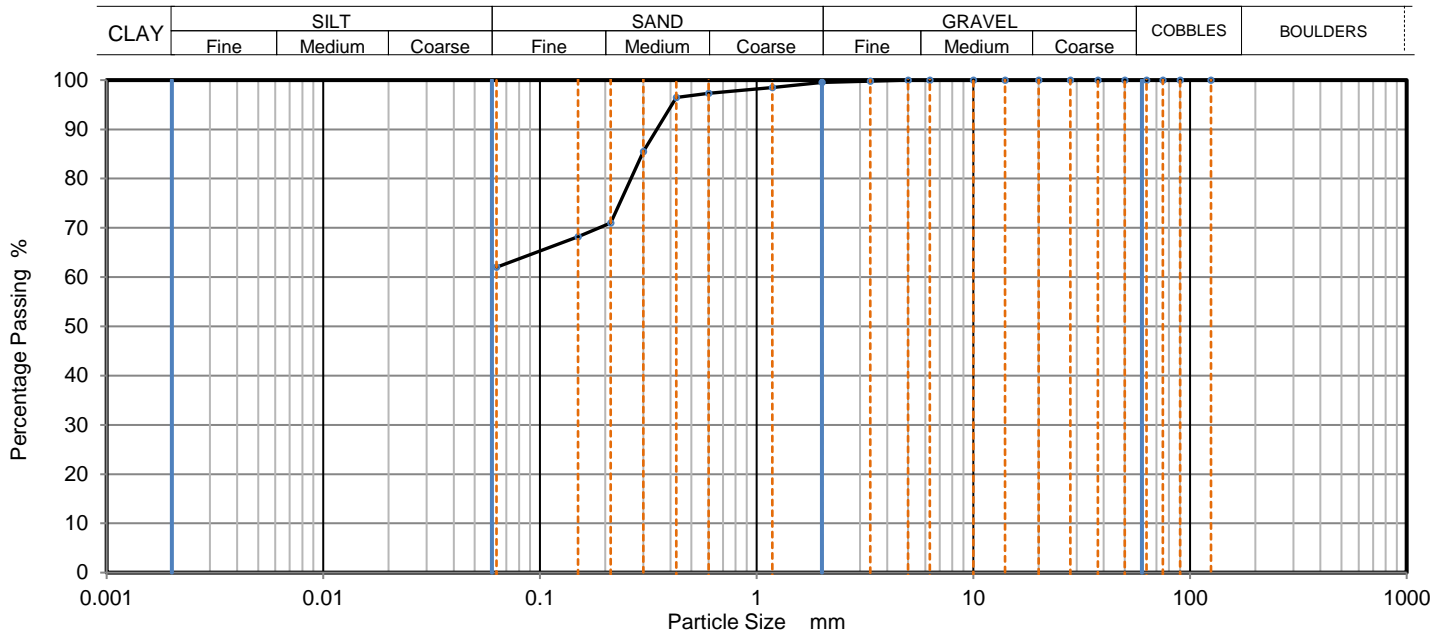
Laboratory Reference: 1173818
Hole No.: WS4
Sample Reference: Not Given
Sample Description: Mottled brown sandy CLAY

Depth Top [m]: 1.50
Depth Base [m]: Not Given
Sample Type: B

Sieving		Sedimentation	
Particle Size mm	% Passing	Particle Size mm	% Passing
125	100		
90	100		
75	100		
63	100		
50	100		
37.5	100		
28	100		
20	100		
14	100		
10	100		
6.3	100		
5	100		
3.35	100		
2	100		
1.18	99		
0.6	97		
0.425	97		
0.3	86		
0.212	71		
0.15	68		
0.063	62

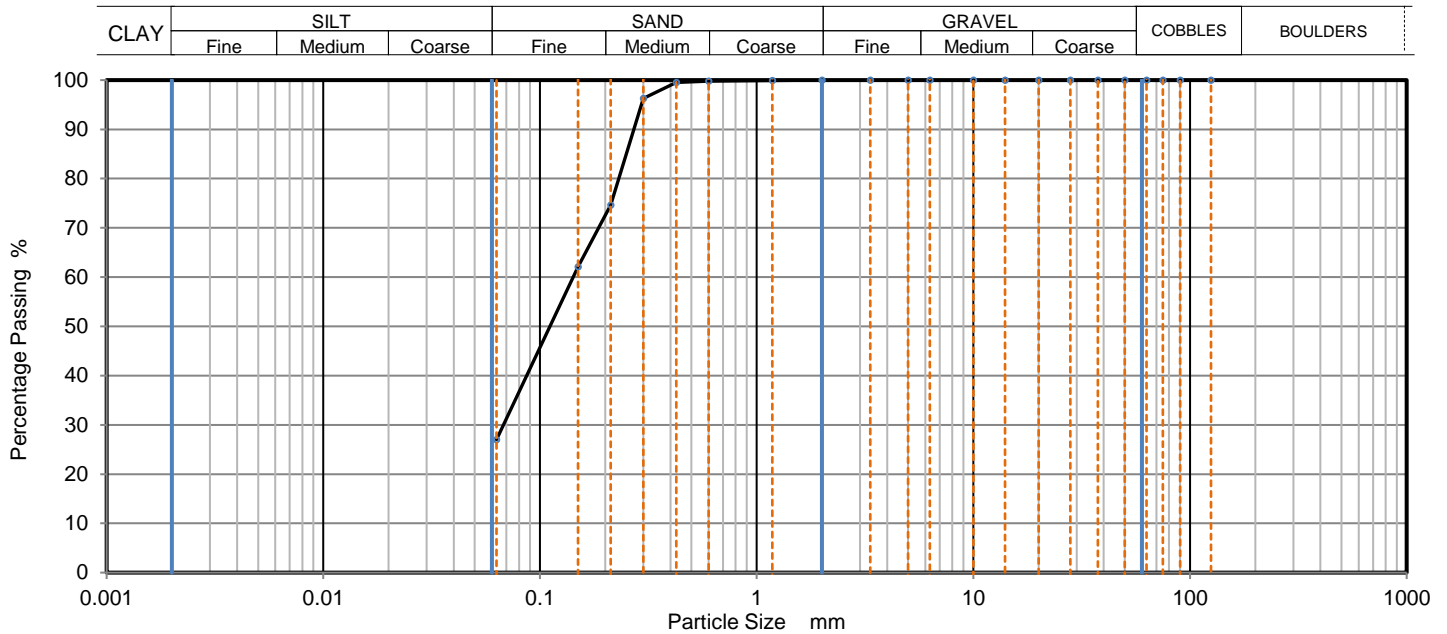
Laboratory Reference: 1173819
Hole No.: WS5
Sample Reference: Not Given
Sample Description: Brown clayey SAND

Depth Top [m]: 3.50
Depth Base [m]: Not Given
Sample Type: D

Sieving		Sedimentation	
Particle Size mm	% Passing	Particle Size mm	% Passing
125	100		
90	100		
75	100		
63	100		
50	100		
37.5	100		
28	100		
20	100		
14	100		
10	100		
6.3	100		
5	100		
3.35	100		
2	100		
1.18	100		
0.6	100		
0.425	100		
0.3	96		
0.212	75		
0.15	62		
0.063	27

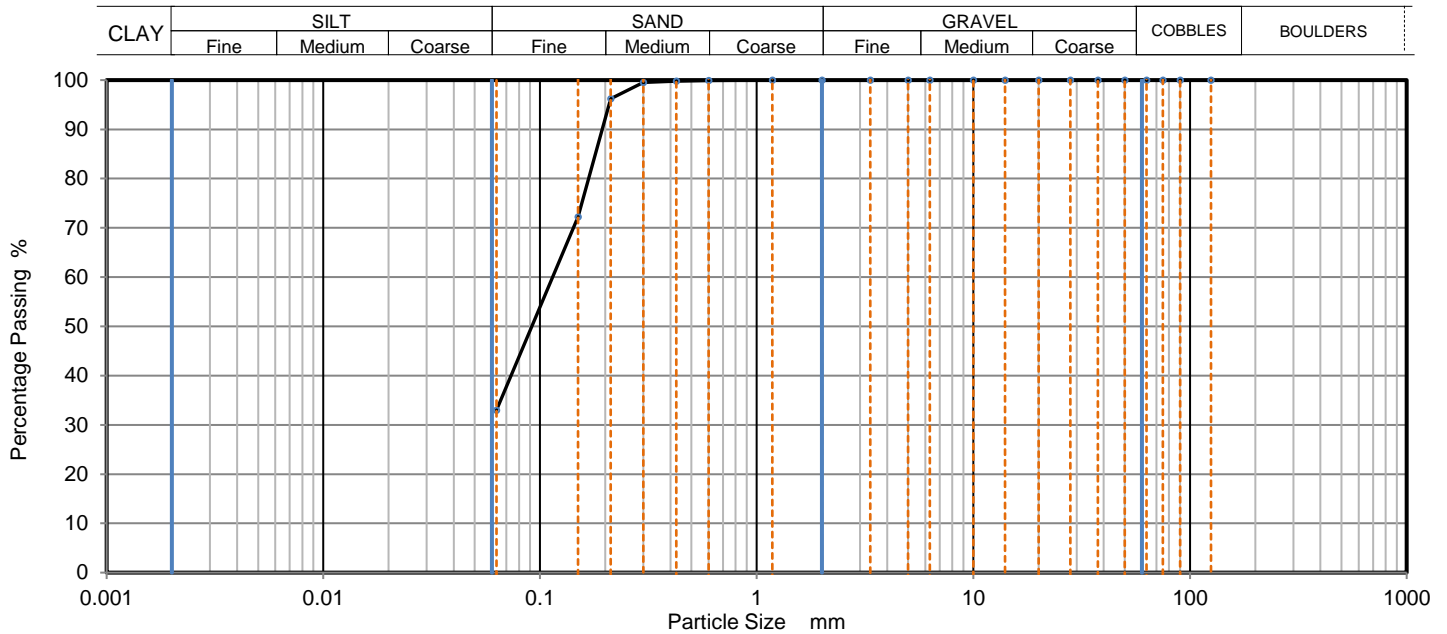
Laboratory Reference: 1173821
Hole No.: WS7
Sample Reference: Not Given
Sample Description: Brown clayey SAND

Depth Top [m]: 3.00
Depth Base [m]: Not Given
Sample Type: B

Sieving		Sedimentation	
Particle Size mm	% Passing	Particle Size mm	% Passing
125	100		
90	100		
75	100		
63	100		
50	100		
37.5	100		
28	100		
20	100		
14	100		
10	100		
6.3	100		
5	100		
3.35	100		
2	100		
1.18	100		
0.6	100		
0.425	100		
0.3	100		
0.212	96		
0.15	72		
0.063	33

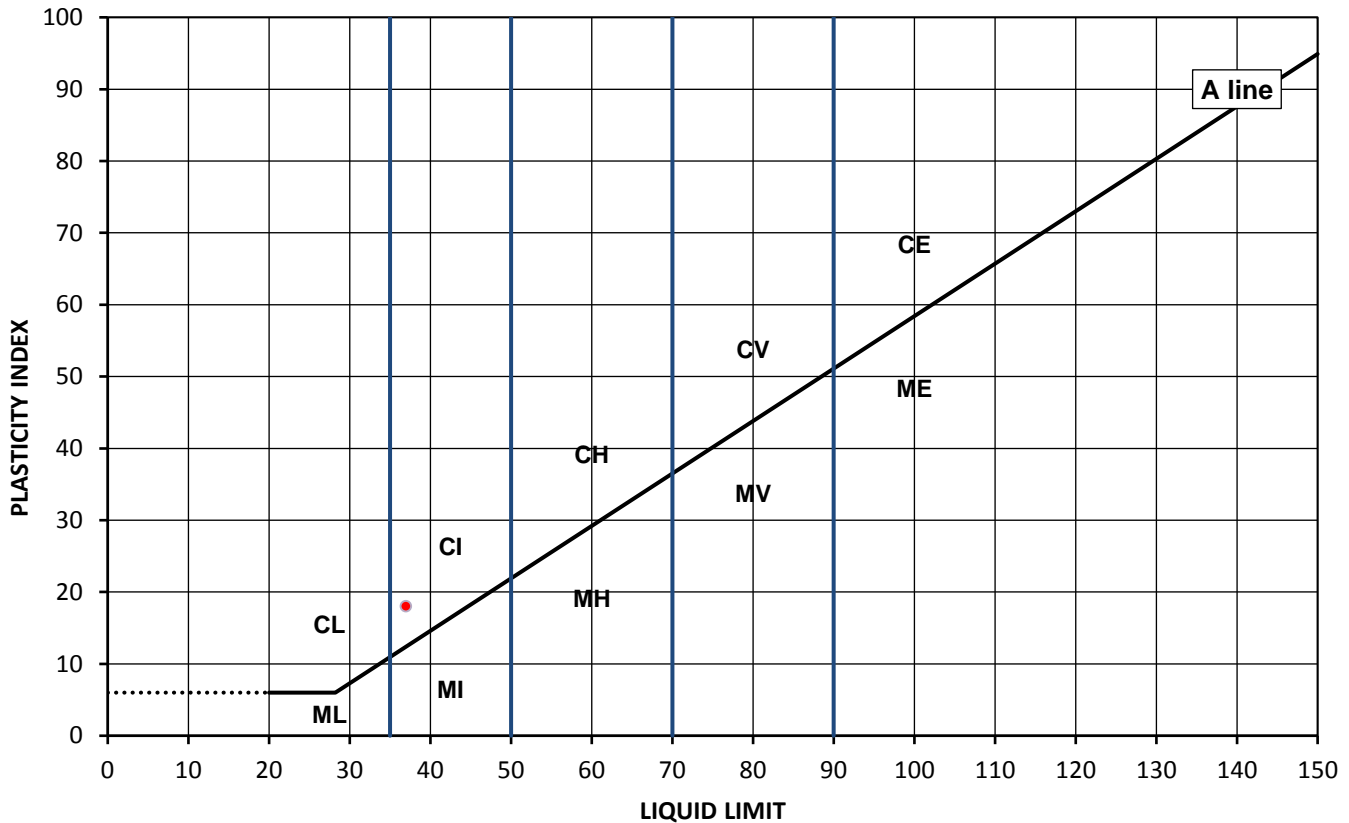
As Received Moisture Content [%]	Liquid Limit [%]	Plastic Limit [%]	Plasticity Index [%]	% Passing 425µm BS Test Sieve
29	37	19	18	100

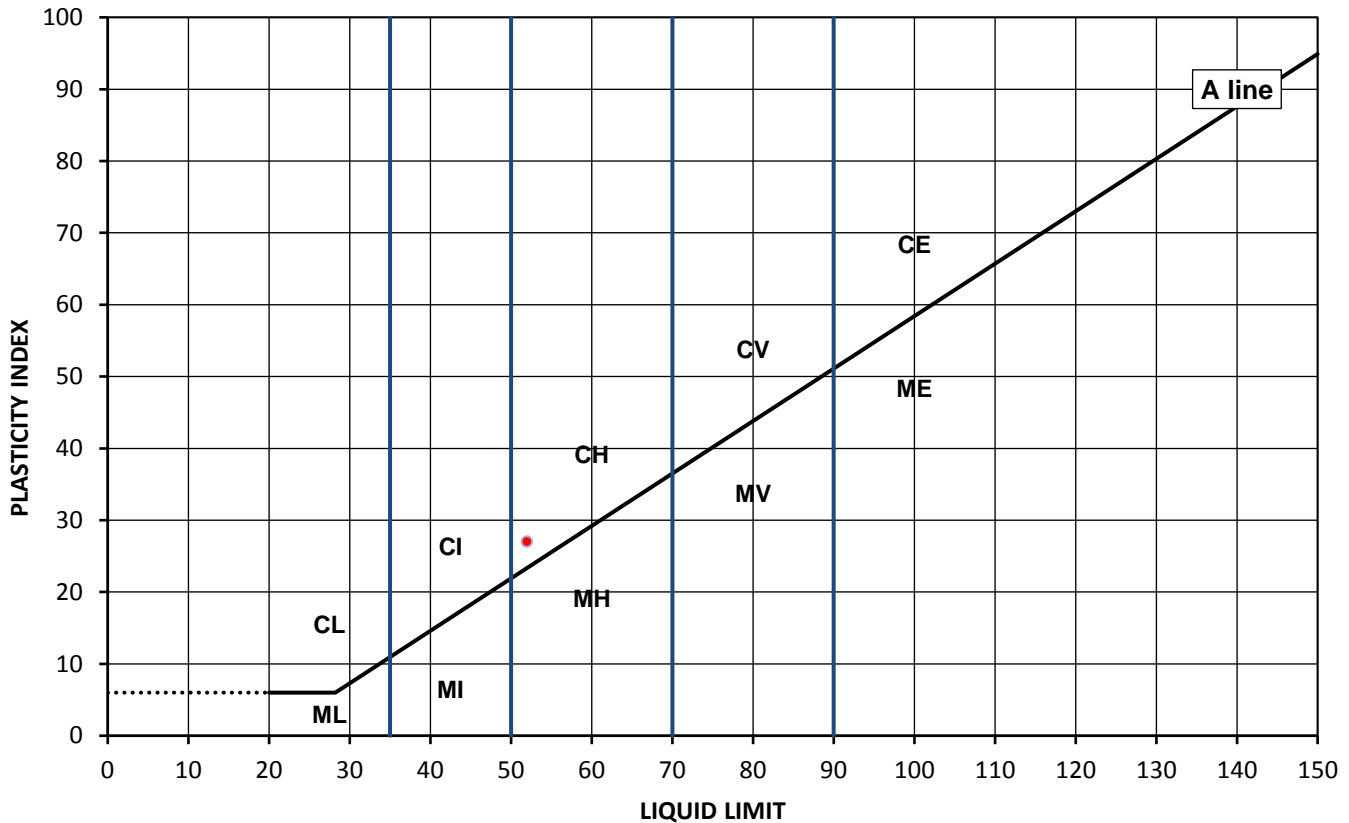
As Received Moisture Content [%]	Liquid Limit [%]	Plastic Limit [%]	Plasticity Index [%]	% Passing 425µm BS Test Sieve
25	52	25	27	100

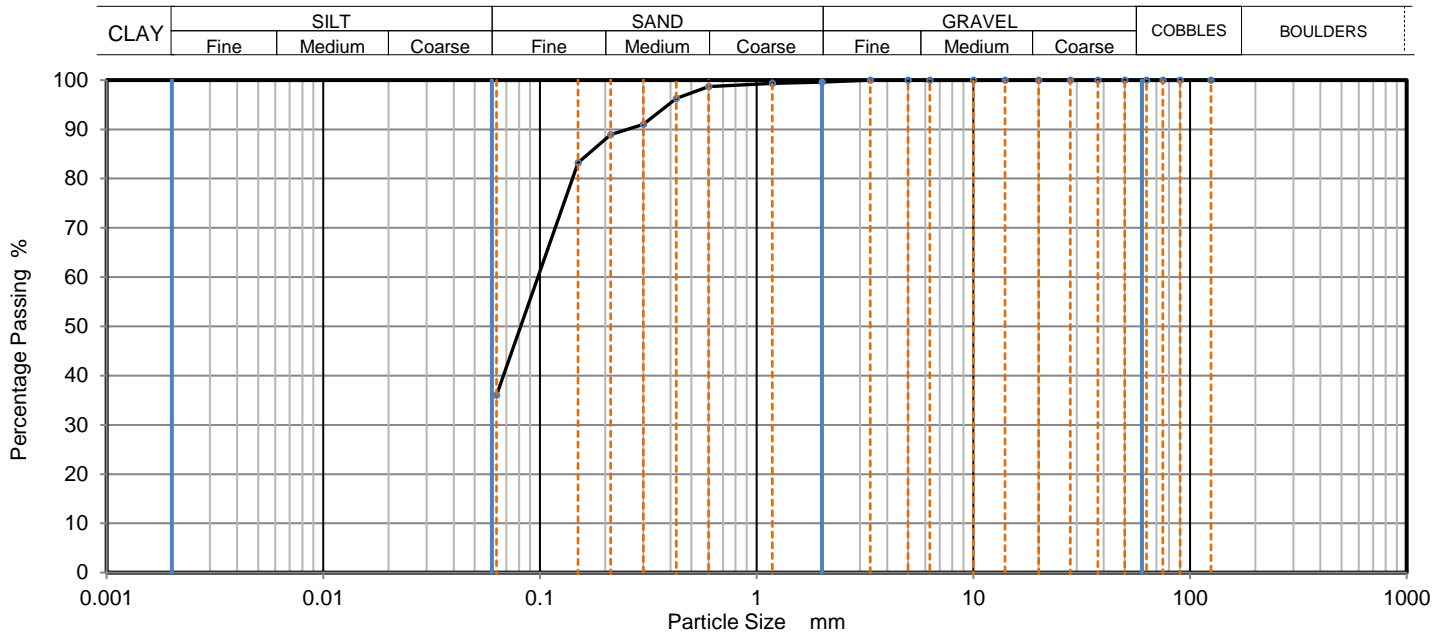
Laboratory Reference: 1160022
Hole No.: BH1
Sample Reference: Not Given
Sample Description: Brown very clayey SAND

Depth Top [m]: 3.50
Depth Base [m]: Not Given
Sample Type: B

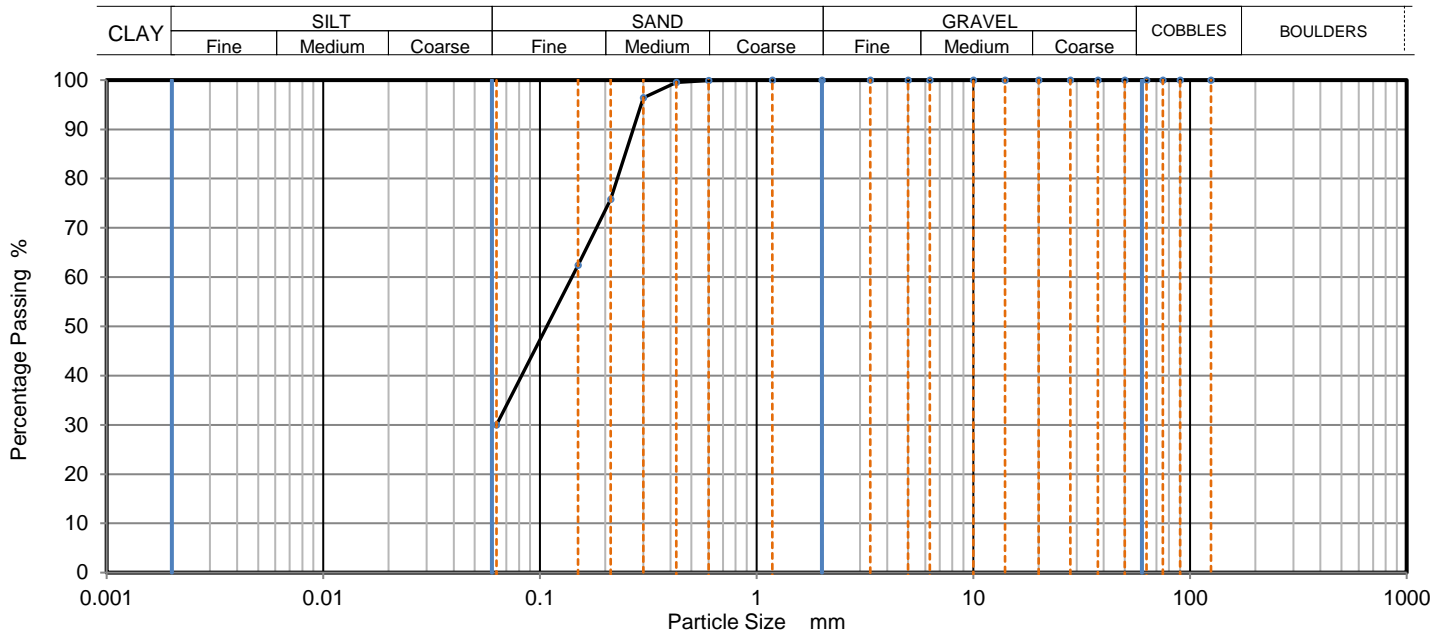
Laboratory Reference: 1160024
Hole No.: BH2
Sample Reference: Not Given
Sample Description: Brown very clayey SAND

Depth Top [m]: 4.50
Depth Base [m]: Not Given
Sample Type: B

Sieving		Sedimentation	
Particle Size mm	% Passing	Particle Size mm	% Passing
125	100		
90	100		
75	100		
63	100		
50	100		
37.5	100		
28	100		
20	100		
14	100		
10	100		
6.3	100		
5	100		
3.35	100		
2	100		
1.18	100		
0.6	100		
0.425	100		
0.3	96		
0.212	76		
0.15	62		
0.063	30

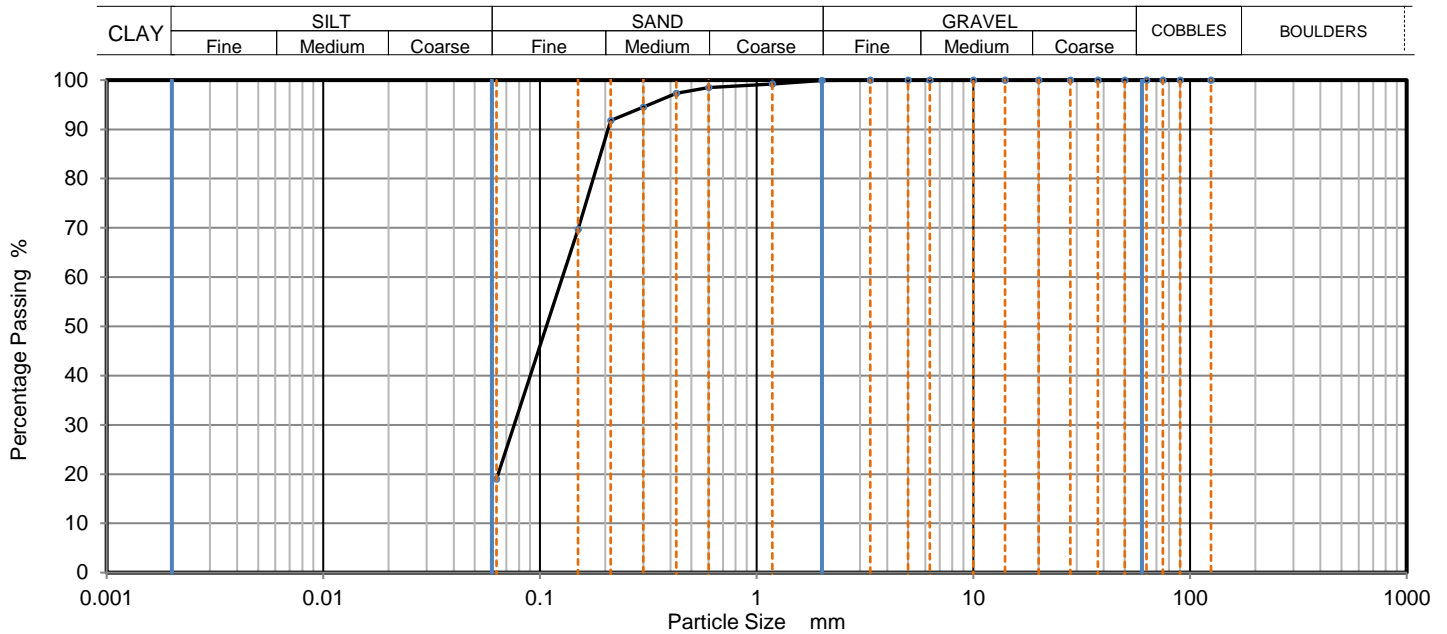
Laboratory Reference: 1160025
Hole No.: BH2
Sample Reference: Not Given
Sample Description: Greyish brown clayey SAND

Depth Top [m]: 10.50
Depth Base [m]: Not Given
Sample Type: B

Sieving		Sedimentation	
Particle Size mm	% Passing	Particle Size mm	% Passing
125	100		
90	100		
75	100		
63	100		
50	100		
37.5	100		
28	100		
20	100		
14	100		
10	100		
6.3	100		
5	100		
3.35	100		
2	100		
1.18	99		
0.6	99		
0.425	97		
0.3	95		
0.212	92		
0.15	70		
0.063	20

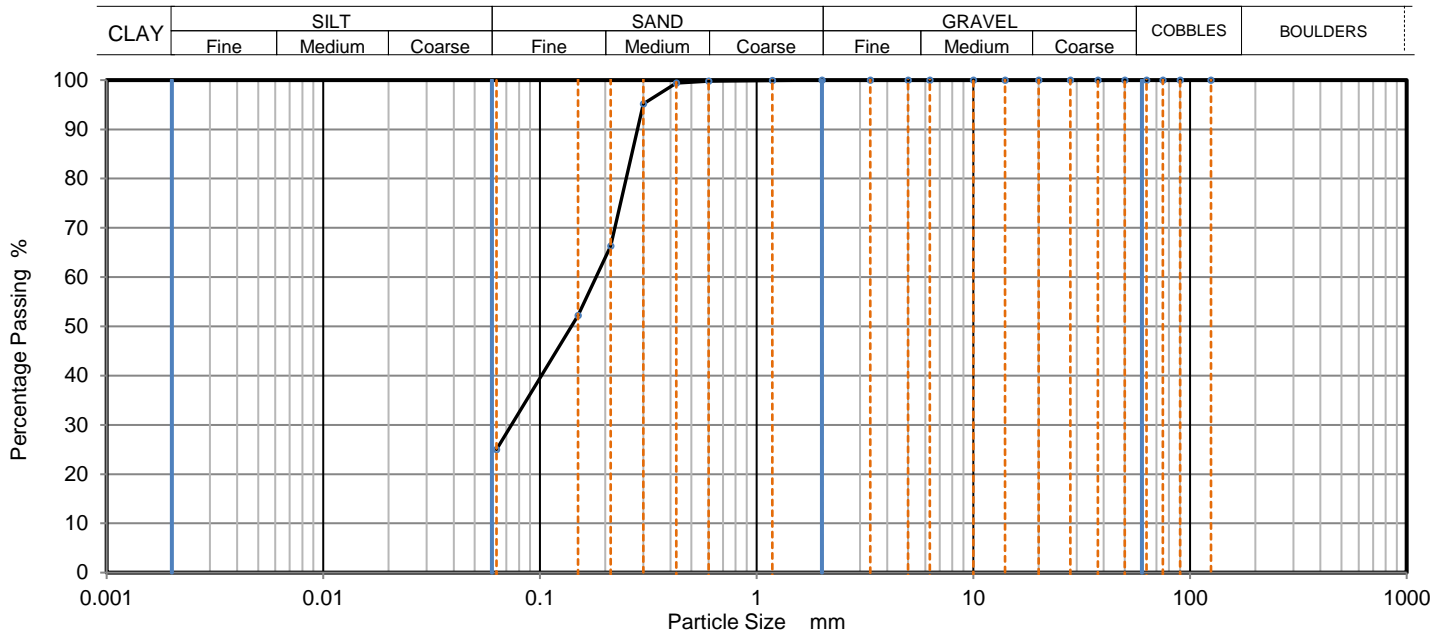
Laboratory Reference: 1160026
Hole No.: BH3
Sample Reference: Not Given
Sample Description: Brown very clayey SAND

Depth Top [m]: 4.00
Depth Base [m]: Not Given
Sample Type: B

Sieving		Sedimentation	
Particle Size mm	% Passing	Particle Size mm	% Passing
125	100		
90	100		
75	100		
63	100		
50	100		
37.5	100		
28	100		
20	100		
14	100		
10	100		
6.3	100		
5	100		
3.35	100		
2	100		
1.18	100		
0.6	100		
0.425	99		
0.3	95		
0.212	66		
0.15	52		
0.063	26

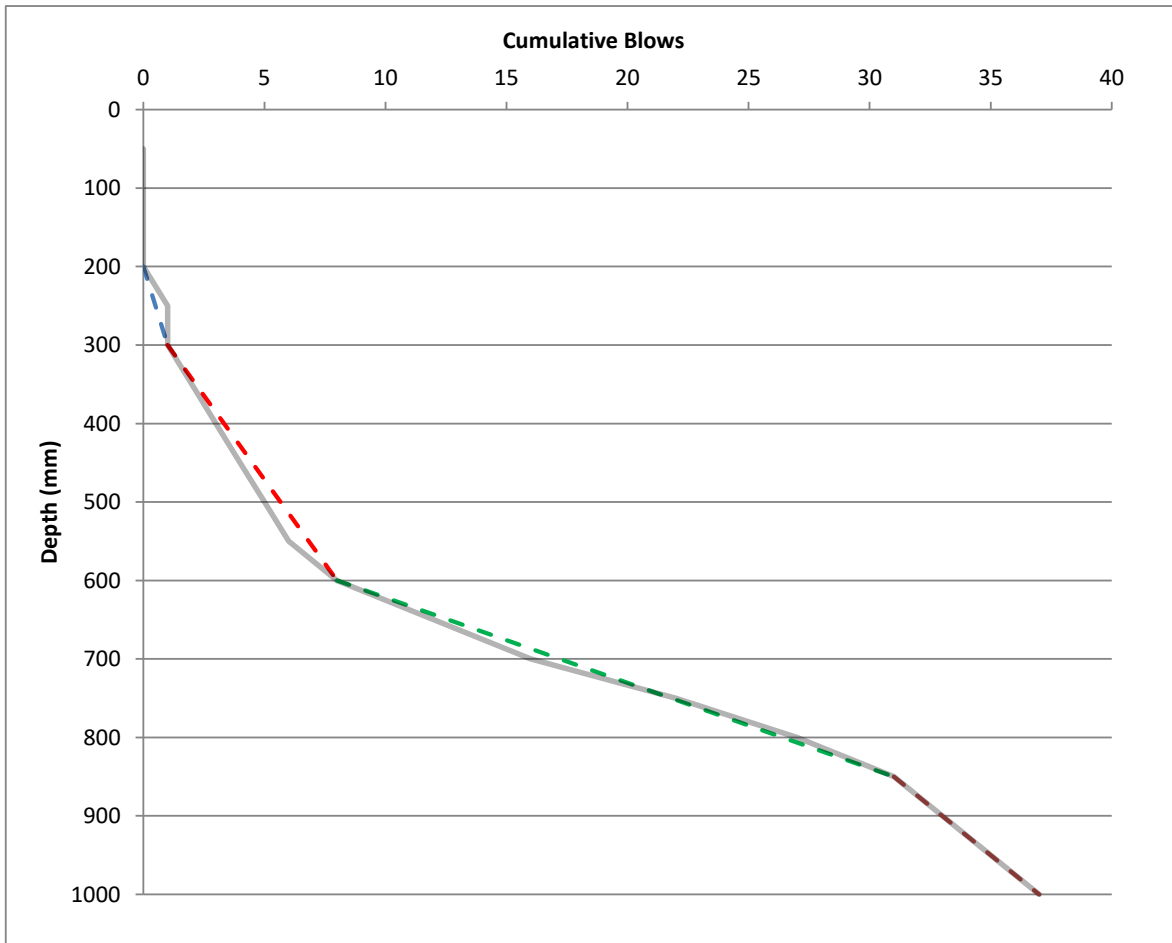
Test carried out using a Perth Probe type dynamic cone probe consisting of a 8 kg free fall hammer lifted and dropped through a height of 575mm
 Colour of text refers to the modelled gradient on graph below
 GL - 0.70m: Brown to orange sandy gravelly clay. Gravel consists of flint, brick, concrete and plastic fragments. (MADE GROUND)
 0.70m - 1.00m: Brown mottled orange silty clayey SAND. Sand is fine to medium. (BAGSHOT FORMATION)

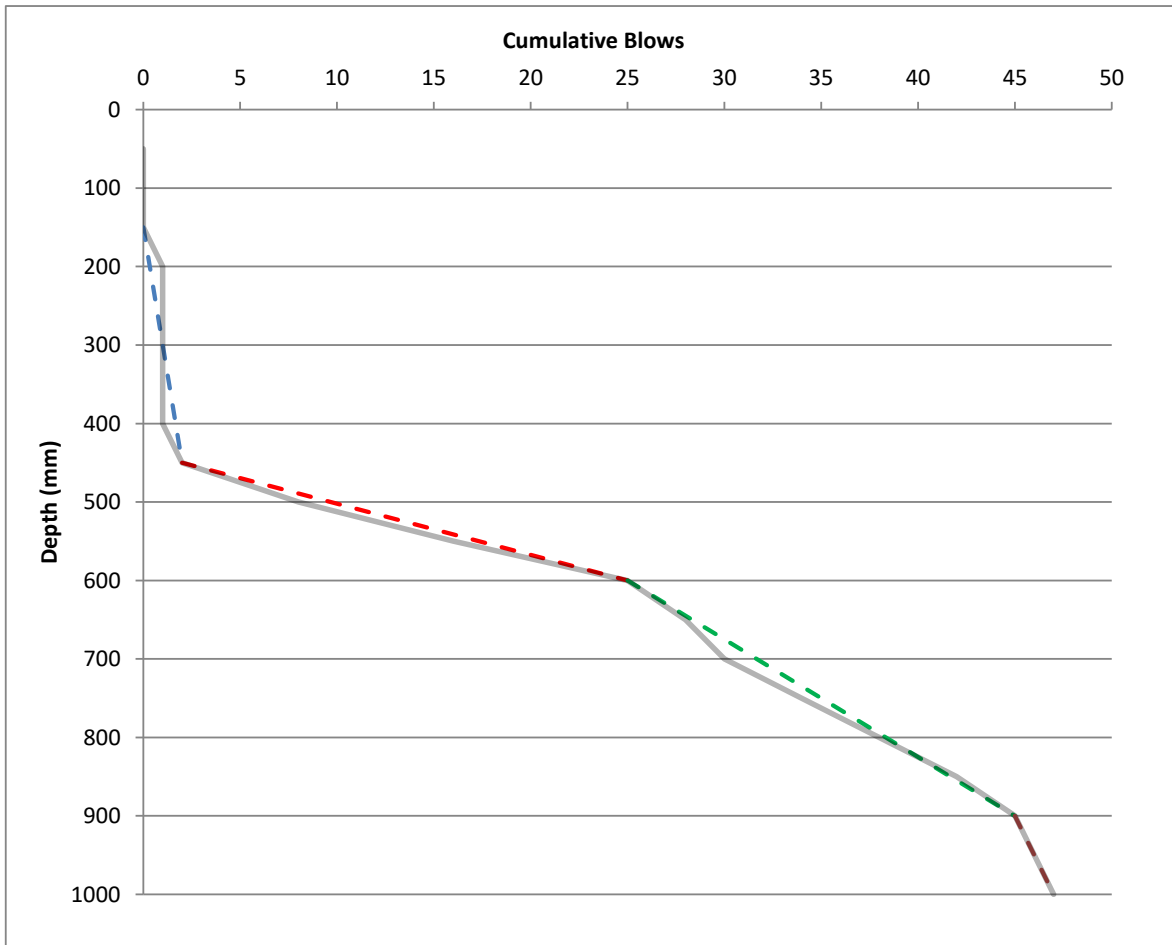
GL - 0.30m: Brown sandy slightly gravelly clay with roots and rootlets. Sand is fine. Gravel consists of brick fragments. (MADE GROUND - Topsoil)

0.3 - 1.0m Brown to orange silty clayey slightly gravelly SAND. Sand is fine to medium. Gravel consists of flint. (BAGSHOT FORMATION)

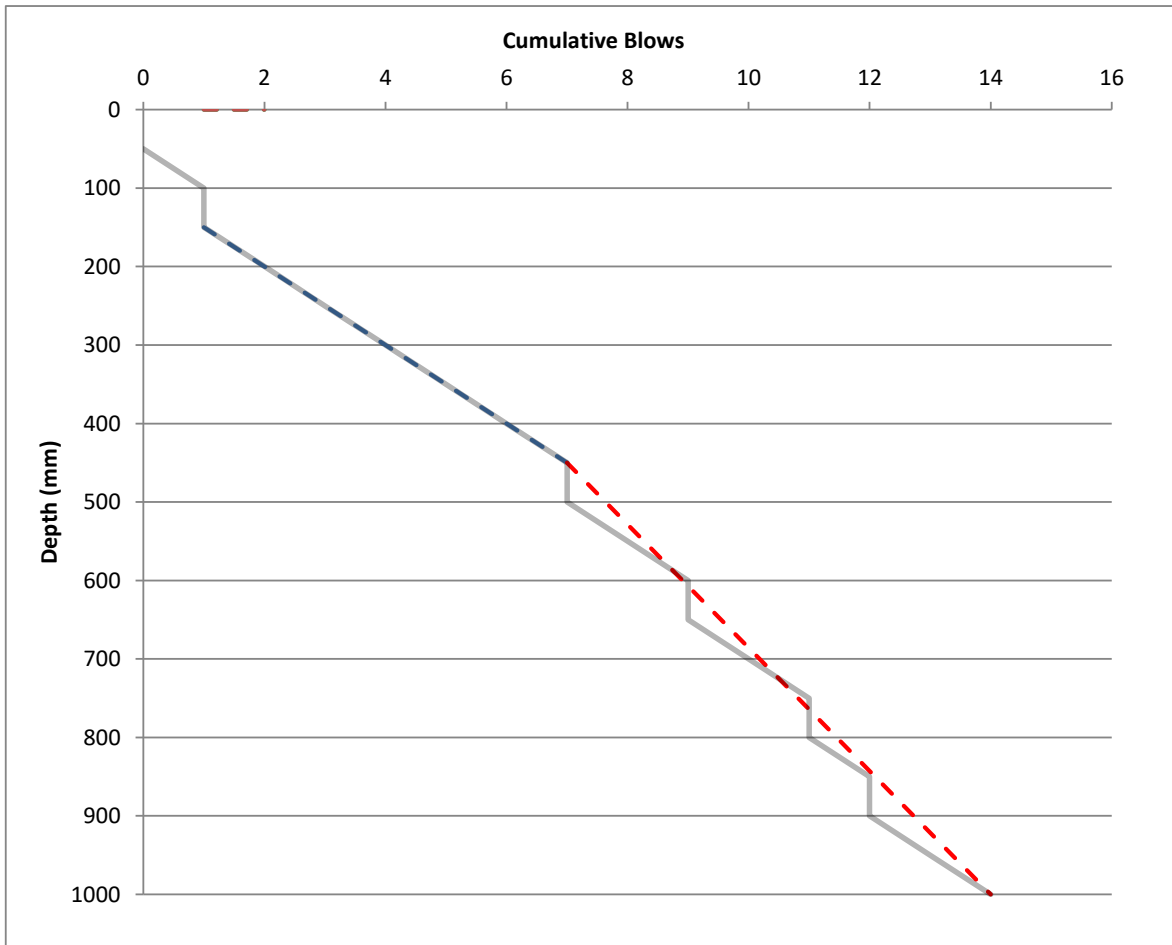
Test carried out using a Perth Probe type dynamic cone probe consisting of a 8 kg free fall hammer lifted and dropped through a height of 575mm
 Colour of text refers to the modelled gradient on graph below
 GL - 0.60m: Brown samdy CLAY with roots and rootlets. Sand is fine. (TOPSOIL)
 0.60 - 1.00m: Brown to orange silty clayey slightly gravelly SAND. Sand is fine to medium. Gravel consists of flint. (BAGSHOT FORMATION)

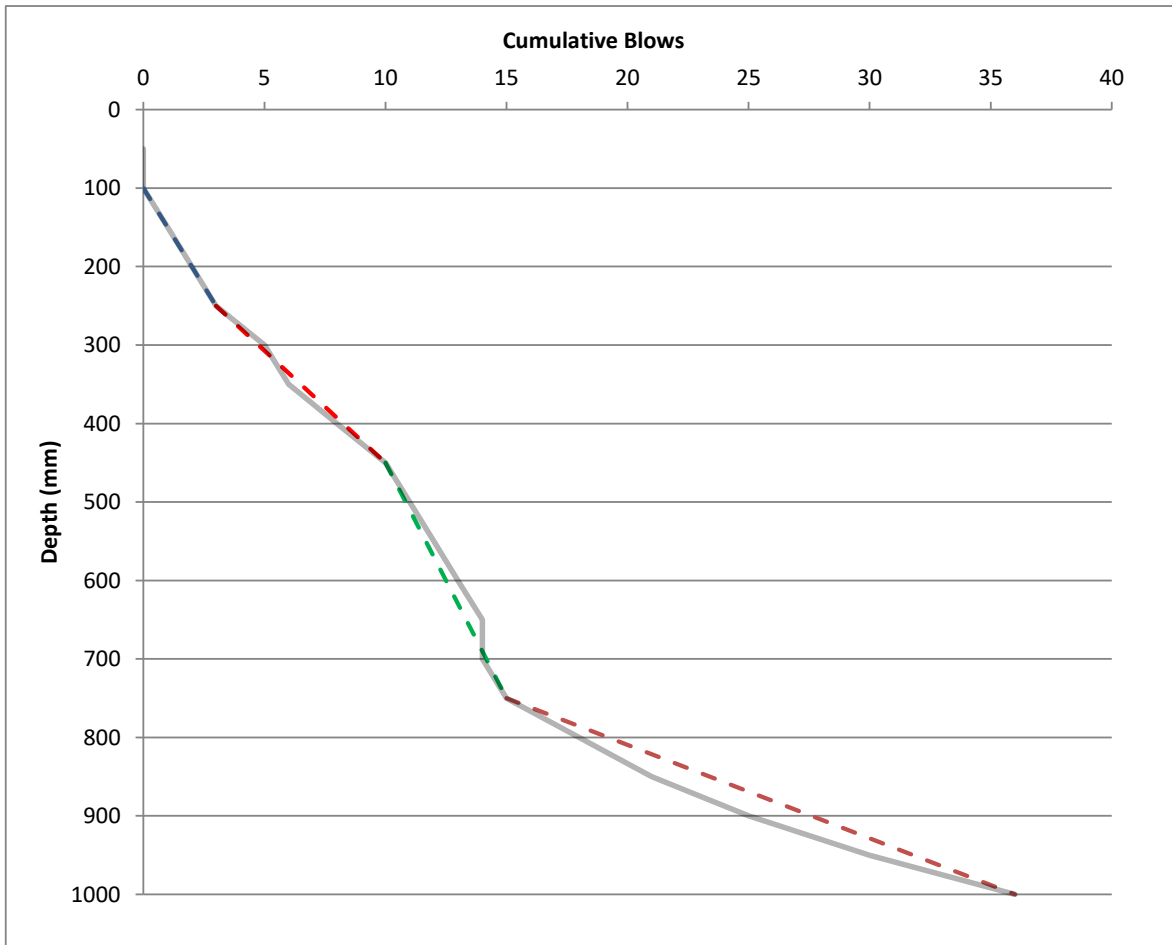
Test carried out using a Perth Probe type dynamic cone probe consisting of a 8 kg free fall hammer lifted and dropped through a height of 575mm
 Colour of text refers to the modelled gradient on graph below
 GL - 0.30m: Brown sandy CLAY with roots and rootlets. Sand is fine. (TOPSOIL)
 0.30 - 1.00m: Brown to orange silty clayey slightly gravelly SAND. Sand is fine to medium.
 Gravel consists of flint. (BAGSHOT FORMATION)

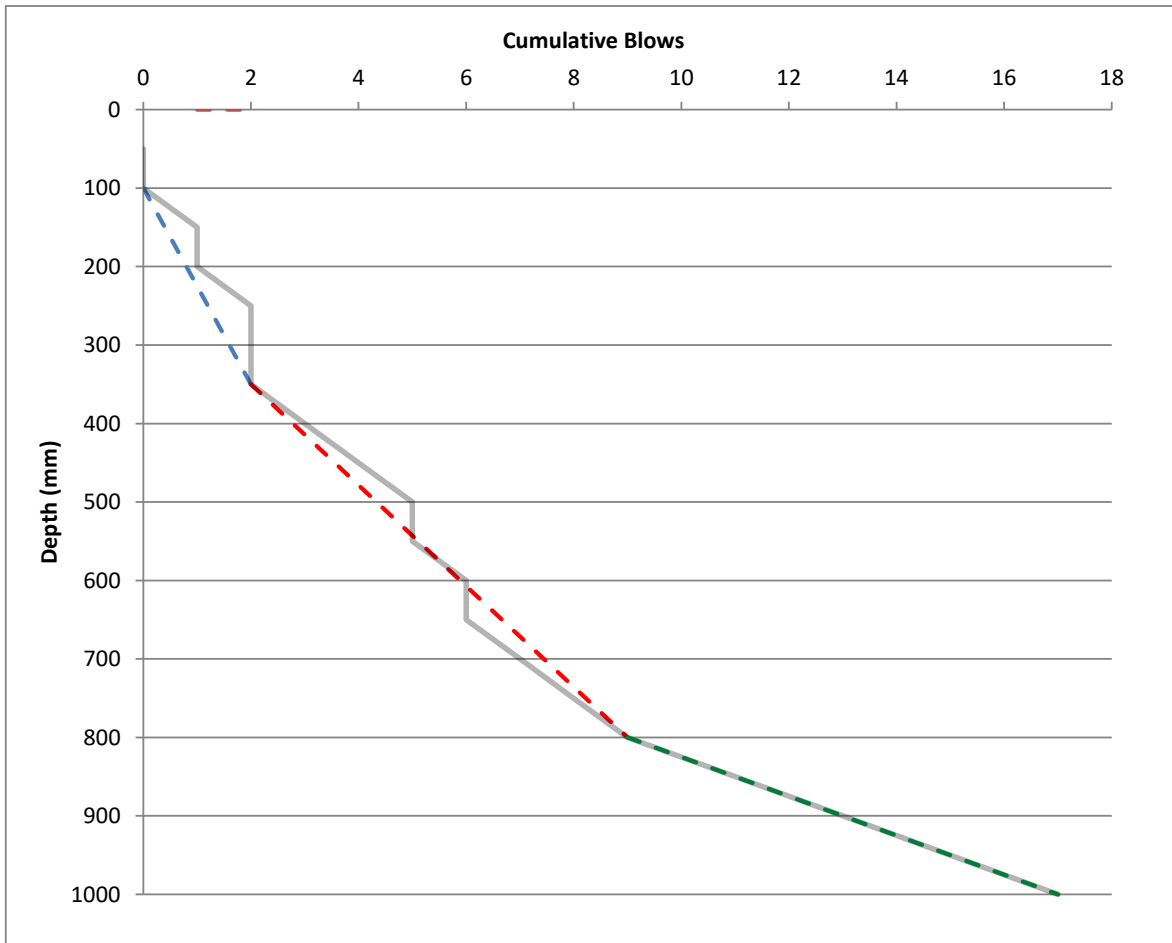
Test carried out using a Perth Probe type dynamic cone probe consisting of a 8 kg free fall hammer lifted and dropped through a height of 575mm
 Colour of text refers to the modelled gradient on graph below
 GL - 0.50m: Brown sandy CLAY with roots and rootlets. Sand is fine. (TOPSOIL)
 0.50m - 1.00m: Brown to orange silty clayey slightly gravelly SAND. Sand is fine to medium. Gravel consists of flint. (BAGSHOT FORMATION)
