# **Appendix: Water Resources, Drainage and Flood Risk**

# **Annex 1: Legislative and Planning Policy Context**

Figure 1.1: **Site Location Plan**  
 Client: **Woking Football Club**  
 Project: **Woking Sites EIA**  
 Project No.: **C1947**

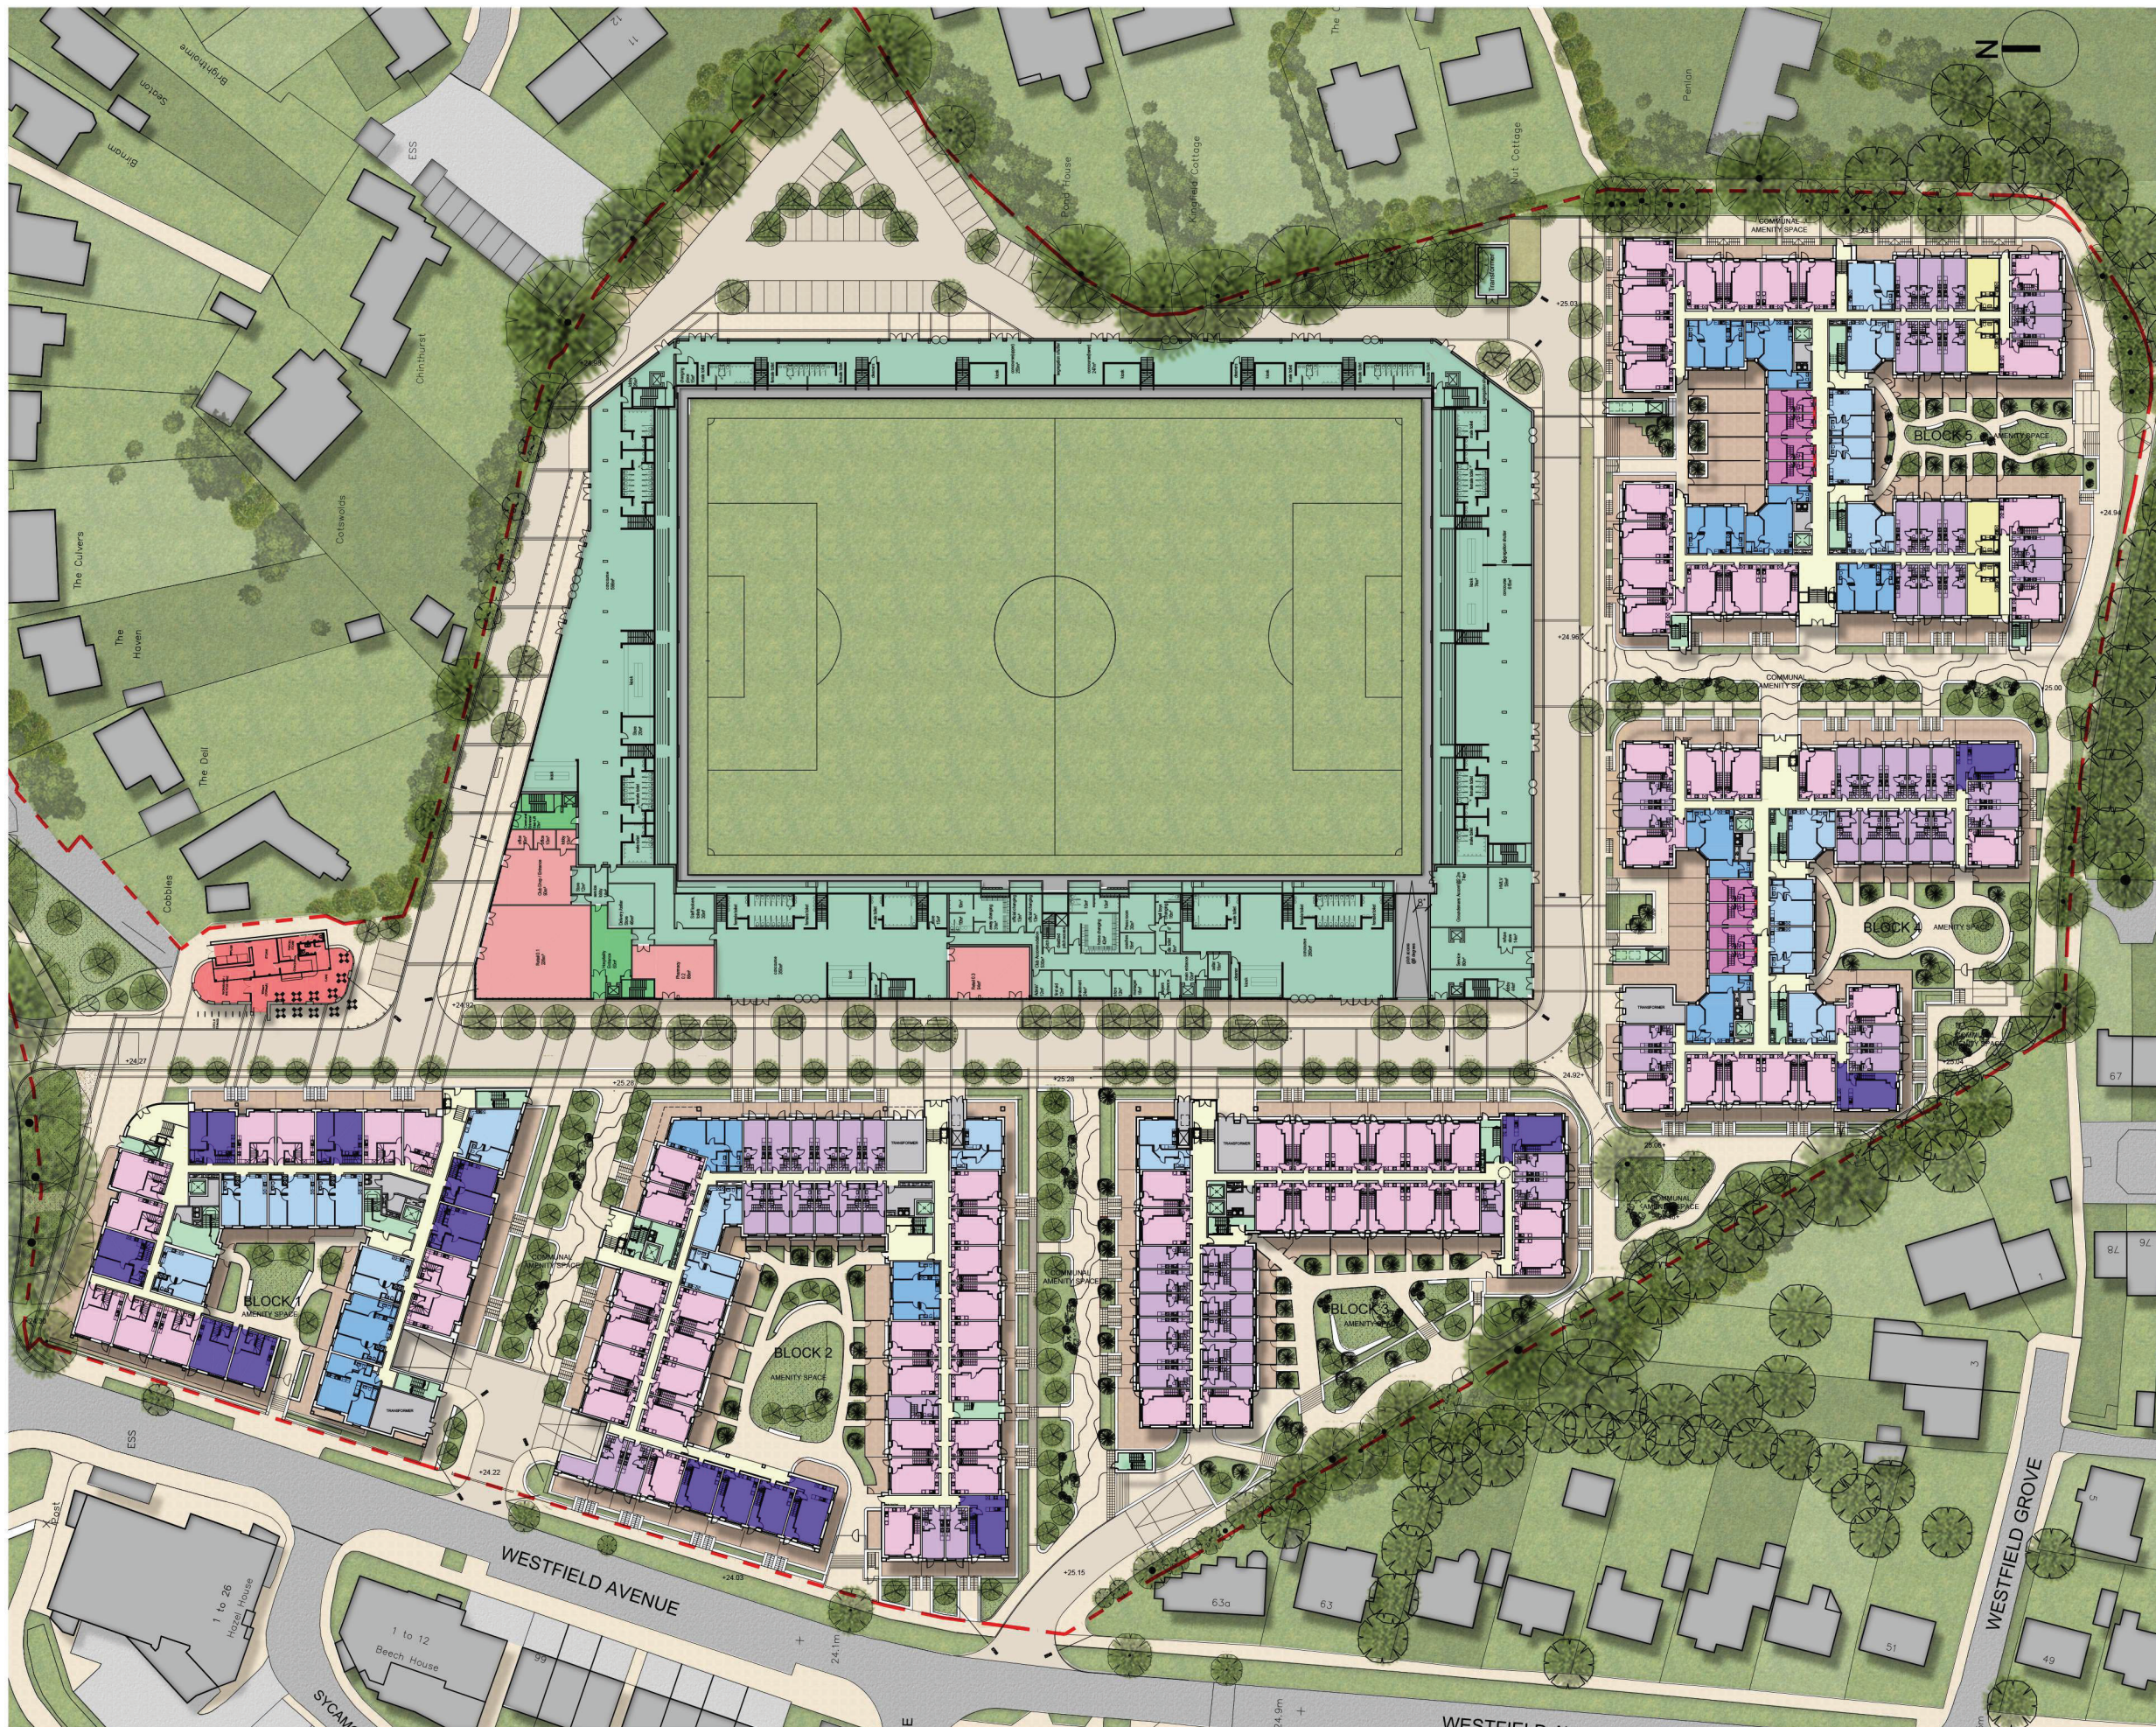
## ***Appendix A: Proposed Development Layout***

- KEY**
- STUDIO APARTMENT
  - 1 BEDROOM APARTMENT
  - 1 BEDROOM DUPLEX / TOWNHOUSE
  - 2 BEDROOM APARTMENT
  - 2 BEDROOM TOWNHOUSE
  - 2 BEDROOM UPPER DUPLEX
  - 2 BEDROOM LOWER DUPLEX
  - 3 BEDROOM APARTMENT / TOWNHOUSE
  - COMMUNITY CONCIERGE
  - COMMERCIAL AREA
  - DOCTORS AND DENTIST FACILITY
  - STADIUM

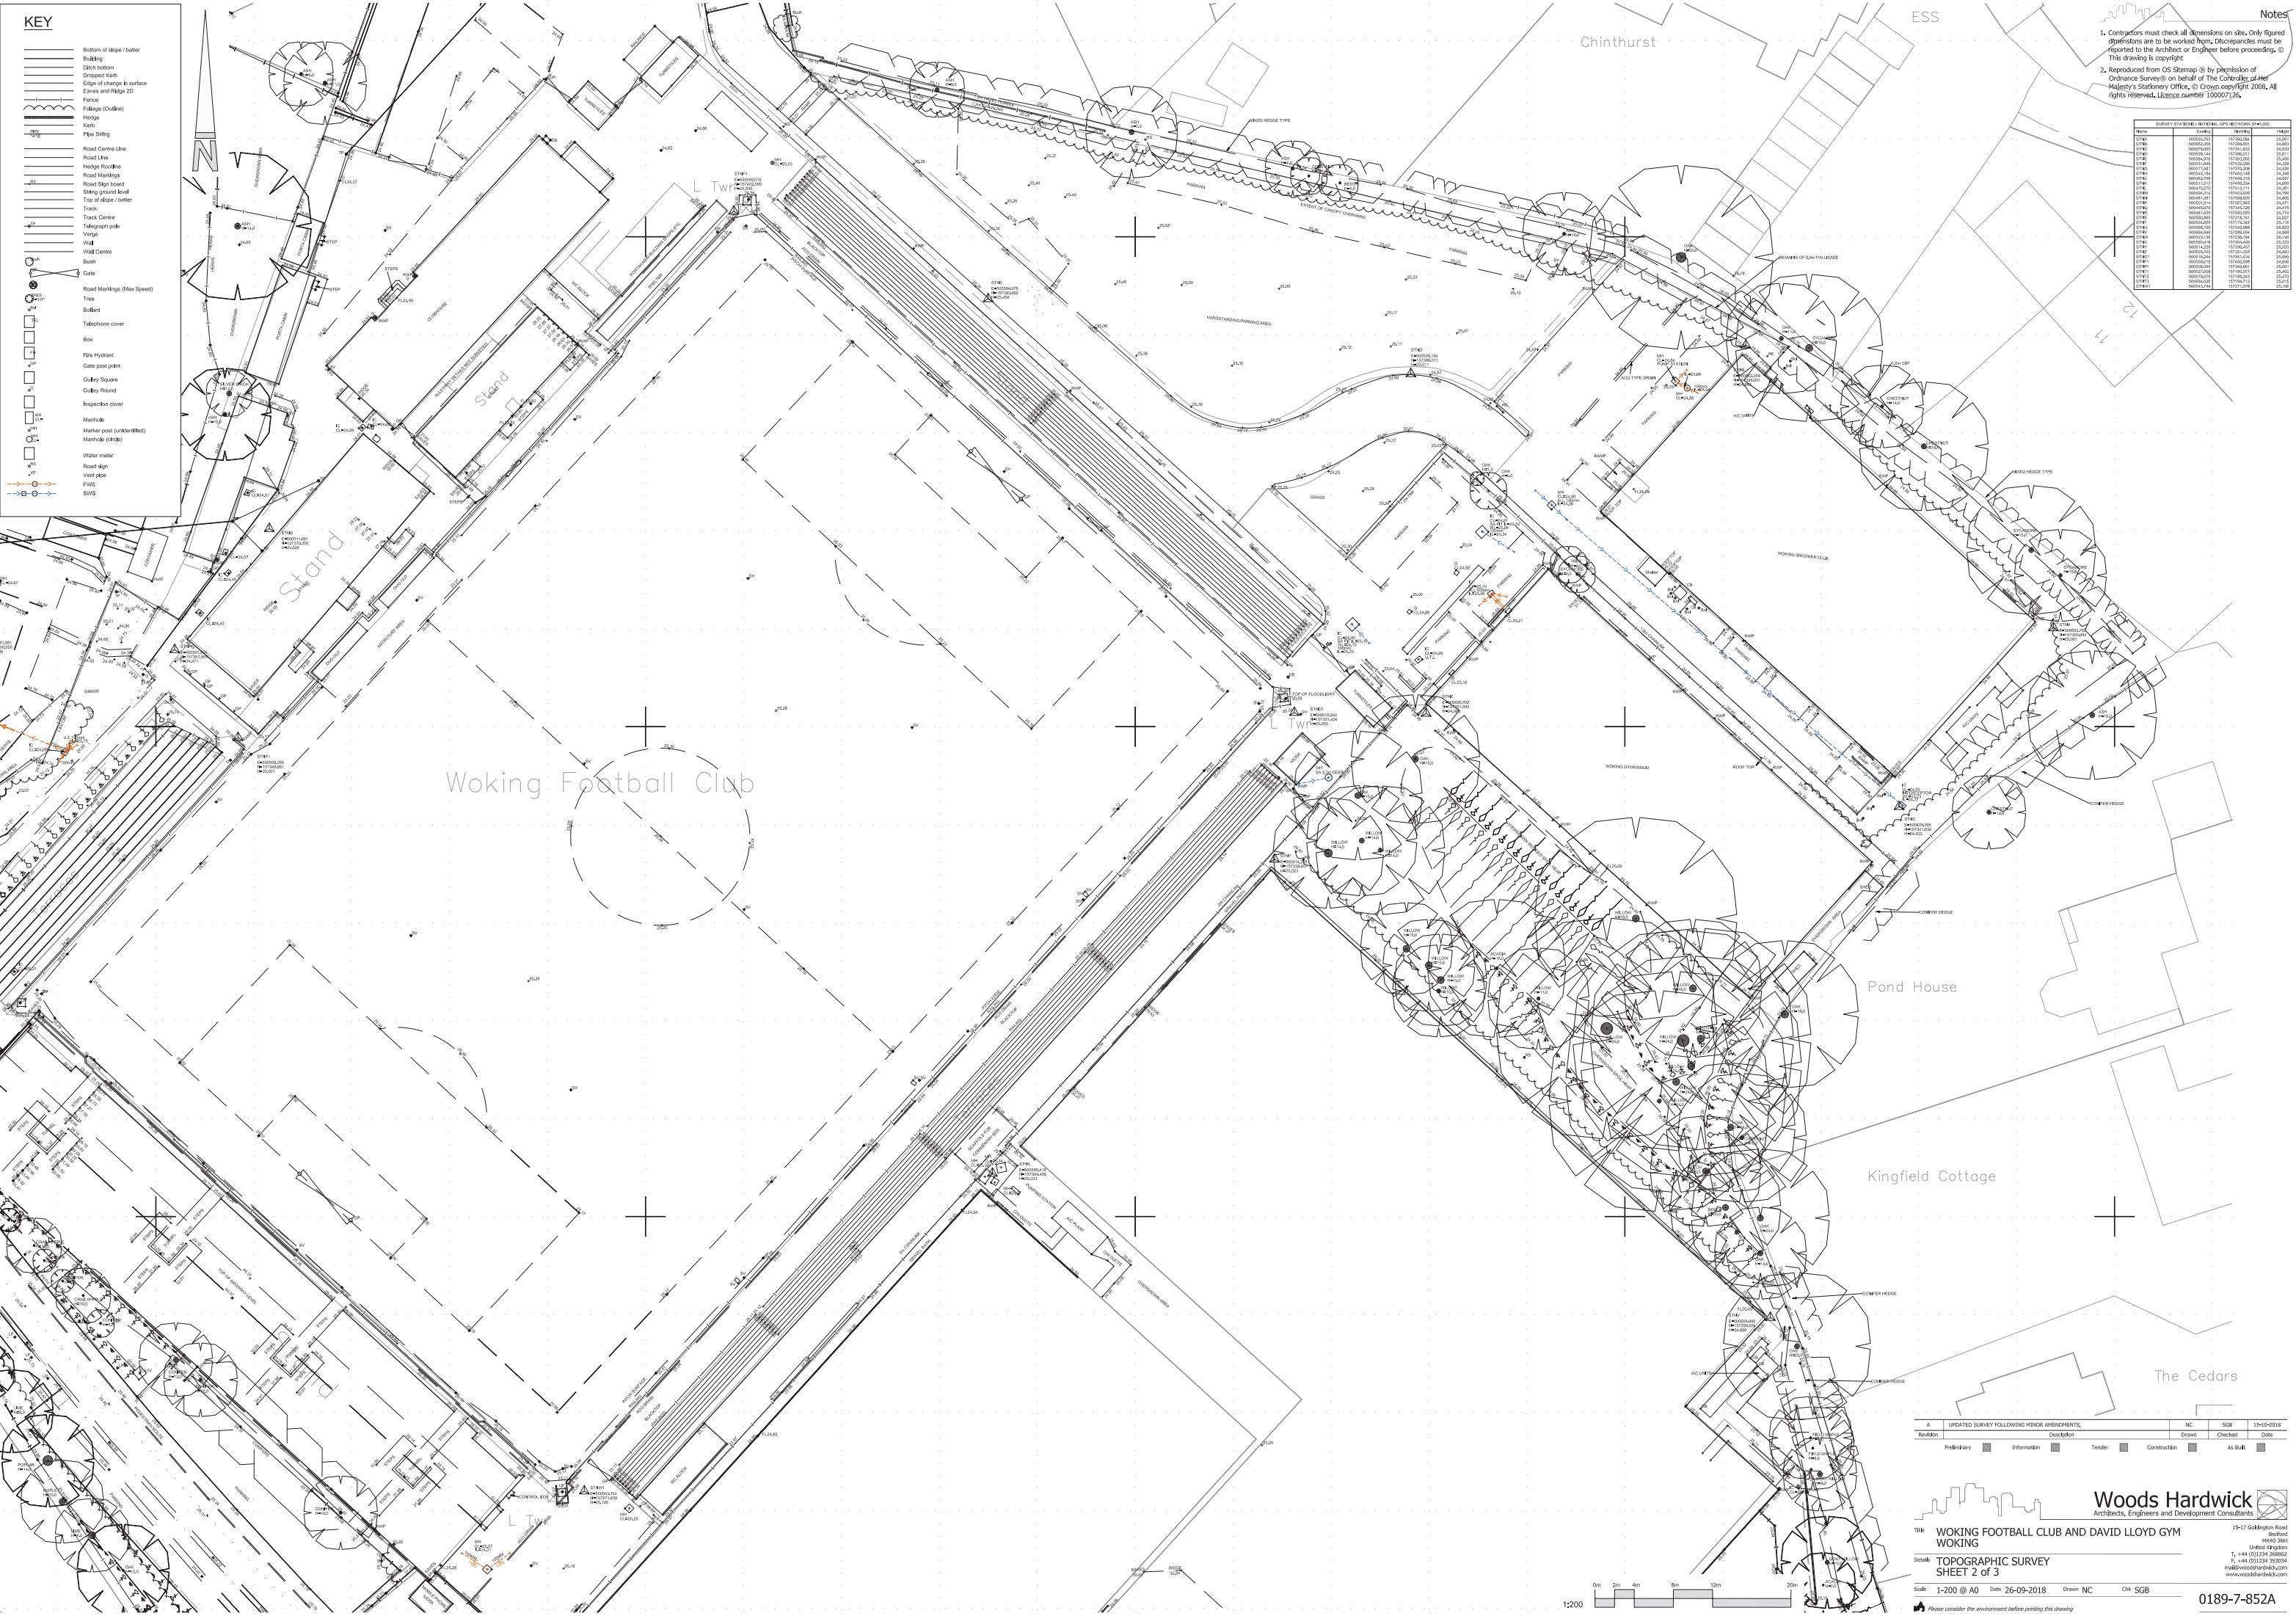
STW6	00001545	19726316	25201
STW6	00001546	19726317	25201
STW6	00001547	19726318	25201
STW6	00001548	19726319	25201
STW6	00001549	19726320	25201
STW6	00001550	19726321	25201
STW6	00001551	19726322	25201
STW6	00001552	19726323	25201
STW6	00001553	19726324	25201
STW6	00001554	19726325	25201
STW6	00001555	19726326	25201
STW6	00001556	19726327	25201
STW6	00001557	19726328	25201
STW6	00001558	19726329	25201
STW6	00001559	19726330	25201
STW6	00001560	19726331	25201
STW6	00001561	19726332	25201
STW6	00001562	19726333	25201
STW6	00001563	19726334	25201
STW6	00001564	19726335	25201
STW6	00001565	19726336	25201
STW6	00001566	19726337	25201
STW6	00001567	19726338	25201
STW6	00001568	19726339	25201
STW6	00001569	19726340	25201
STW6	00001570	19726341	25201
STW6	00001571	19726342	25201
STW6	00001572	19726343	25201
STW6	00001573	19726344	25201
STW6	00001574	19726345	25201
STW6	00001575	19726346	25201
STW6	00001576	19726347	25201
STW6	00001577	19726348	25201

STW6	00001578	19726349	25201
STW6	00001579	19726350	25201
STW6	00001580	19726351	25201
STW6	00001581	19726352	25201
STW6	00001582	19726353	25201
STW6	00001583	19726354	25201
STW6	00001584	19726355	25201
STW6	00001585	19726356	25201
STW6	00001586	19726357	25201
STW6	00001587	19726358	25201
STW6	00001588	19726359	25201
STW6	00001589	19726360	25201
STW6	00001590	19726361	25201
STW6	00001591	19726362	25201
STW6	00001592	19726363	25201
STW6	00001593	19726364	25201
STW6	00001594	19726365	25201
STW6	00001595	19726366	25201
STW6	00001596	19726367	25201
STW6	00001597	19726368	25201
STW6	00001598	19726369	25201
STW6	00001599	19726370	25201
STW6	00001600	19726371	25201

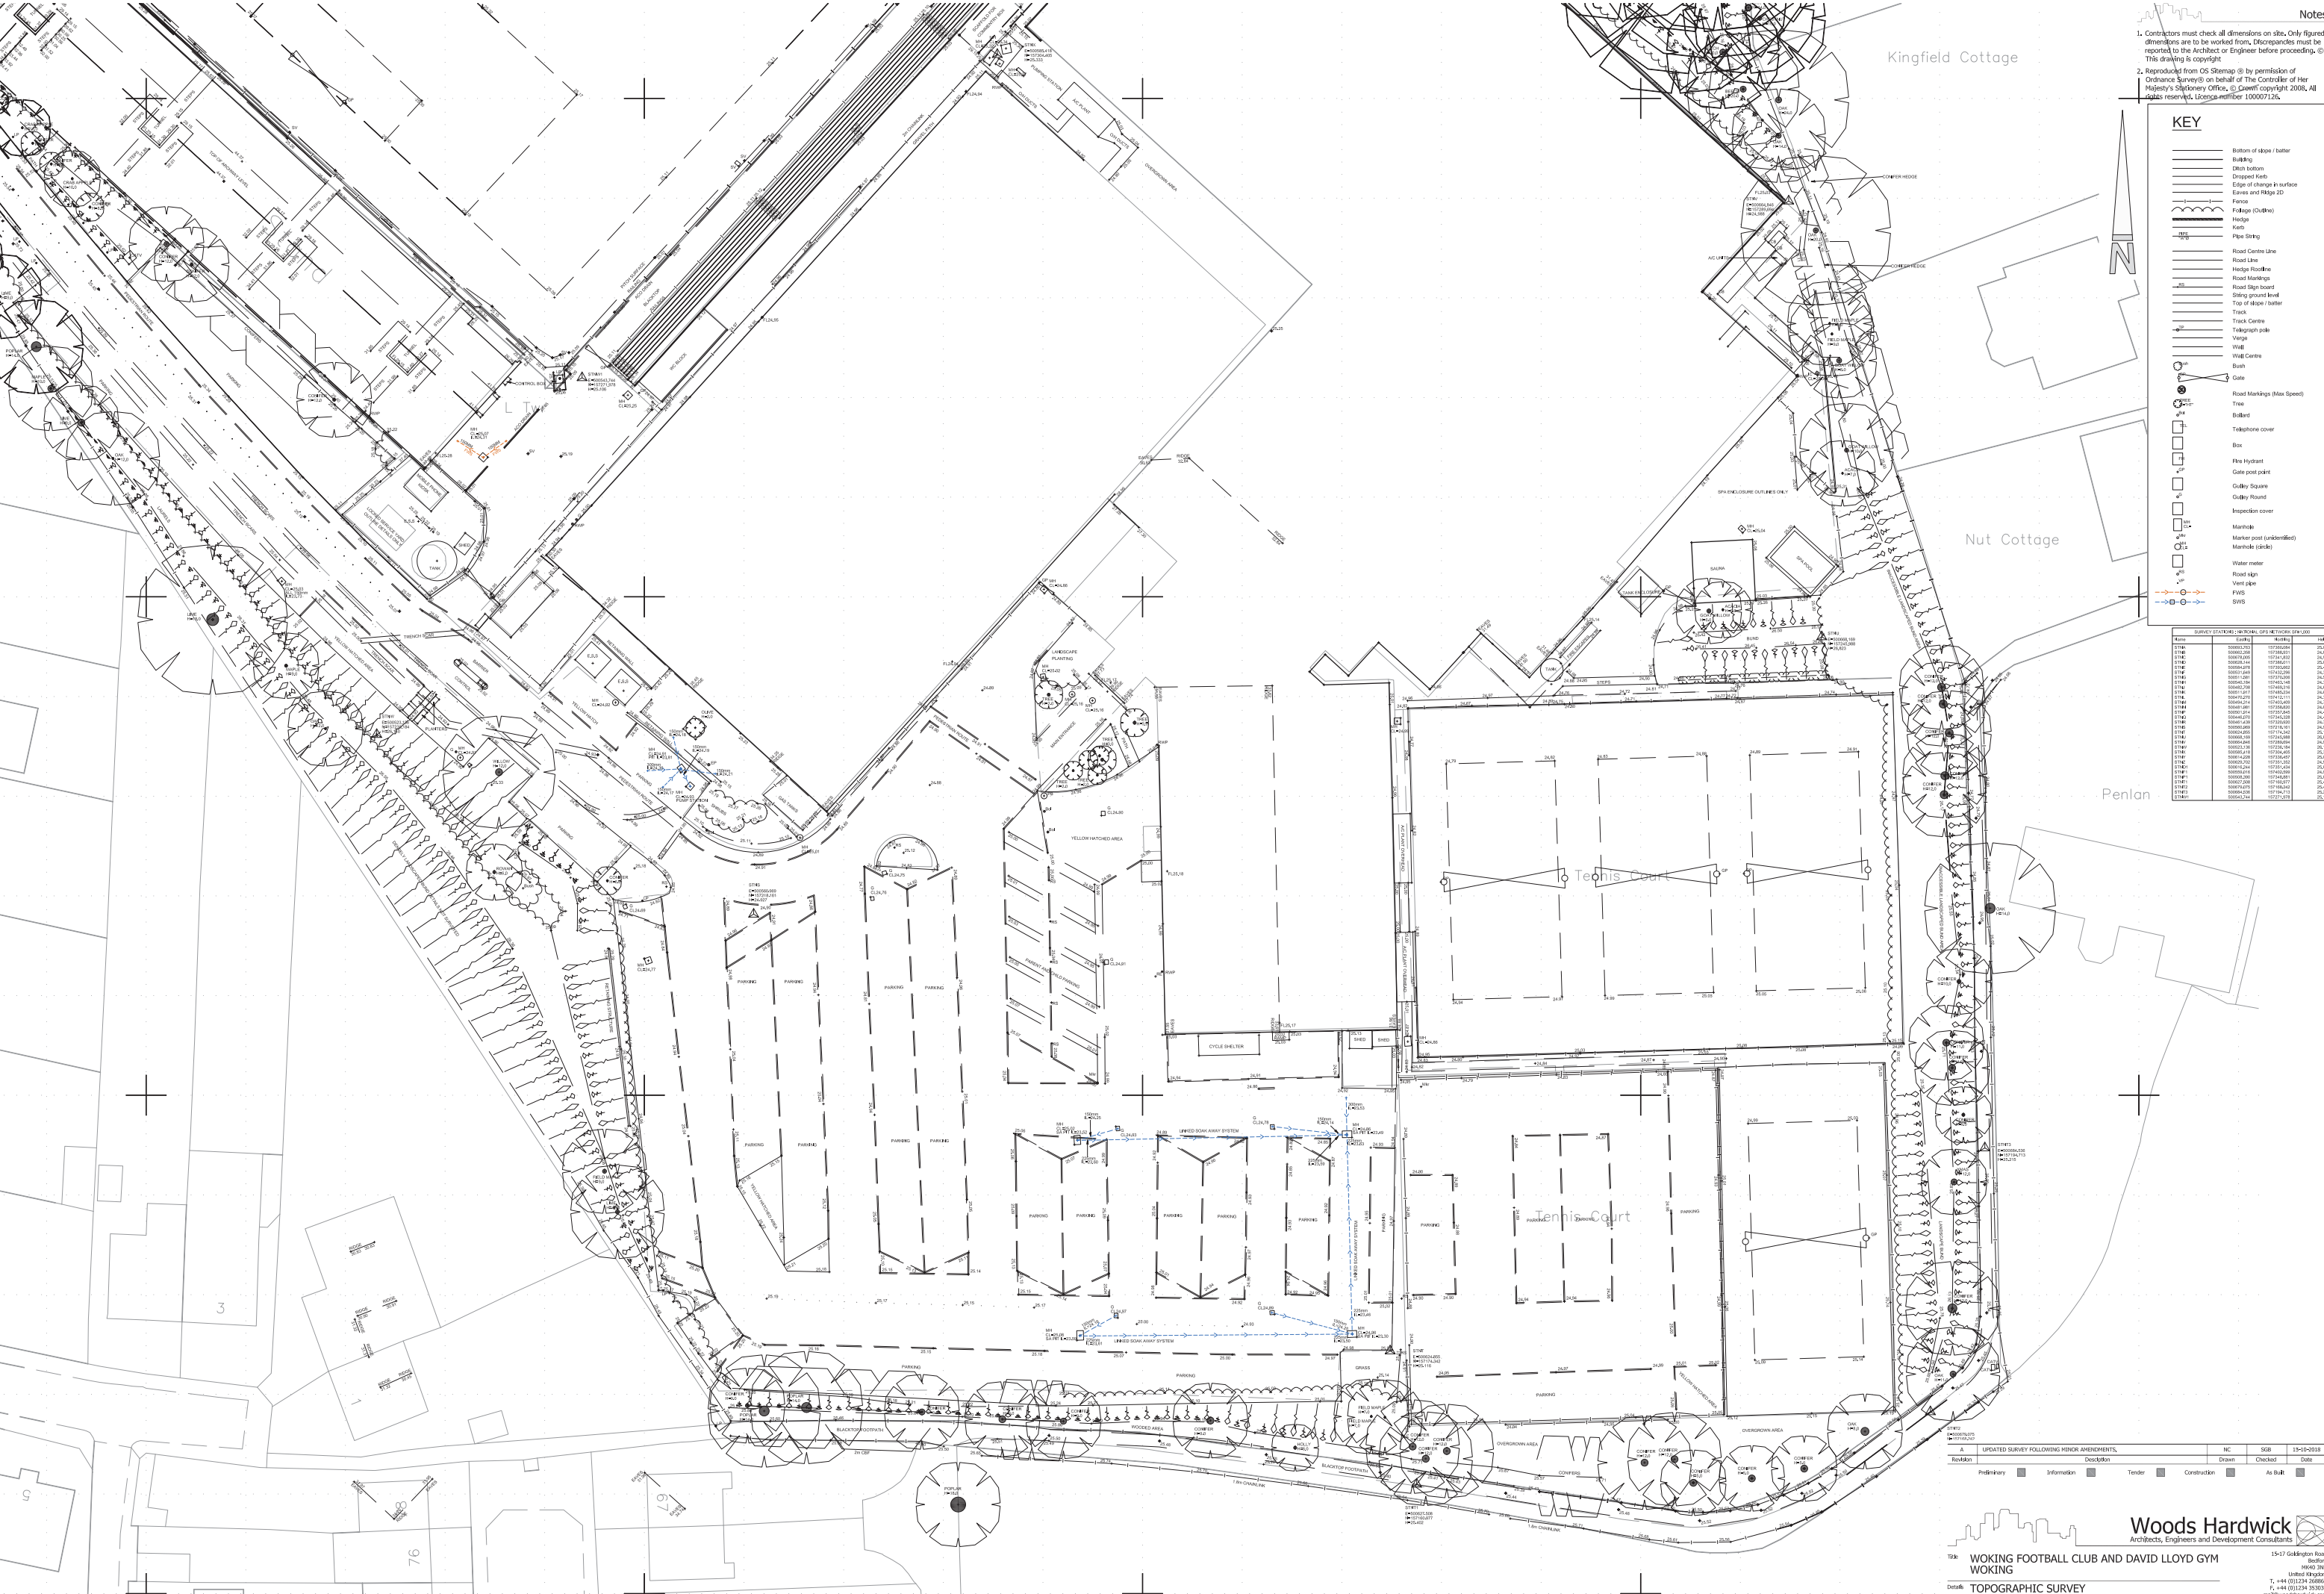
Name	OS Grid	OS Grid	OS Grid	OS Grid
STW1	50862120	10740204	25011	25011
STW2	50862120	10740211	25011	25011
STW3	50862120	10740218	25011	25011
STW4	50862120	10740225	25011	25011
STW5	50862120	10740232	25011	25011
STW6	50862120	10740239	25011	25011
STW7	50862120	10740246	25011	25011
STW8	50862120	10740253	25011	25011
STW9	50862120	10740260	25011	25011
STW10	50862120	10740267	25011	25011
STW11	50862120	10740274	25011	25011
STW12	50862120	10740281	25011	25011
STW13	50862120	10740288	25011	25011
STW14	50862120	10740295	25011	25011
STW15	50862120	10740302	25011	25011
STW16	50862120	10740309	25011	25011
STW17	50862120	10740316	25011	25011
STW18	50862120	10740323	25011	25011
STW19	50862120	10740330	25011	25011
STW20	50862120	10740337	25011	25011
STW21	50862120	10740344	25011	25011
STW22	50862120	10740351	25011	25011
STW23	50862120	10740358	25011	25011
STW24	50862120	10740365	25011	25011
STW25	50862120	10740372	25011	25011

STW26	50862120	10740379	25011	25011
STW27	50862120	10740386	25011	25011
STW28	50862120	10740393	25011	25011
STW29	50862120	10740400	25011	25011
STW30	50862120	10740407	25011	25011
